Manhole Inspection Summary

Manhole # S21YY1018MH

Insp Date: **11/27/06 3:28 PM**

Location Address: **FALLS RD**

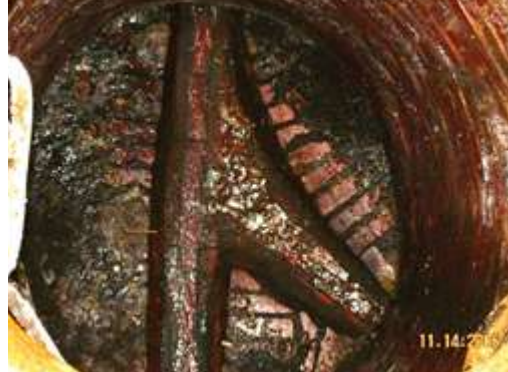
Top View

Bench debris.

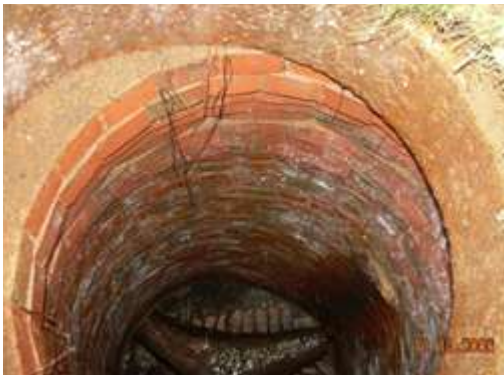
Defect

Frame offset. Adjustment root intrusion and infiltration. Corbel and Barrel infiltration.

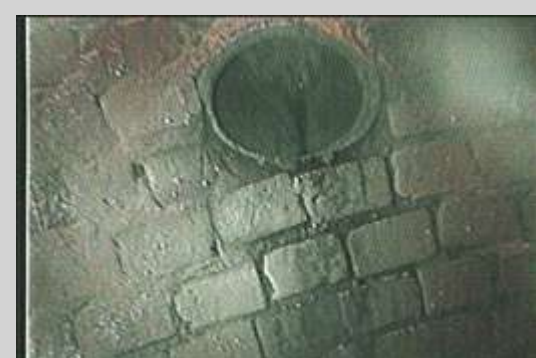
6 in. Circular Gravity Sewer Pipe In @ 4 O'Clock

Infiltration: **Evidence** Pipe Seal Cond: **Broken**

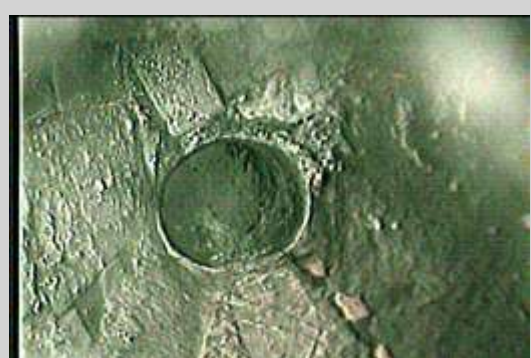
Drop In @ 4 O'Clock

Barrel deterioration and infiltration. Channel deterioration.

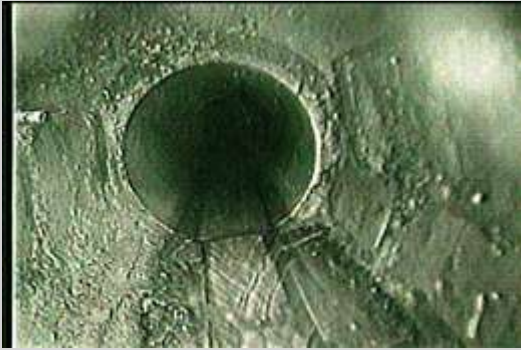
Pipe In @ 6 O'Clock

Channel deterioration.

Infiltration: **Evidence**
